# The Role of Science in the Long-Term Rehabilitation of Delavan Lake, Wis.

**Dale Robertson**

**U.S. Geological Survey, Wisconsin Water Science Center**

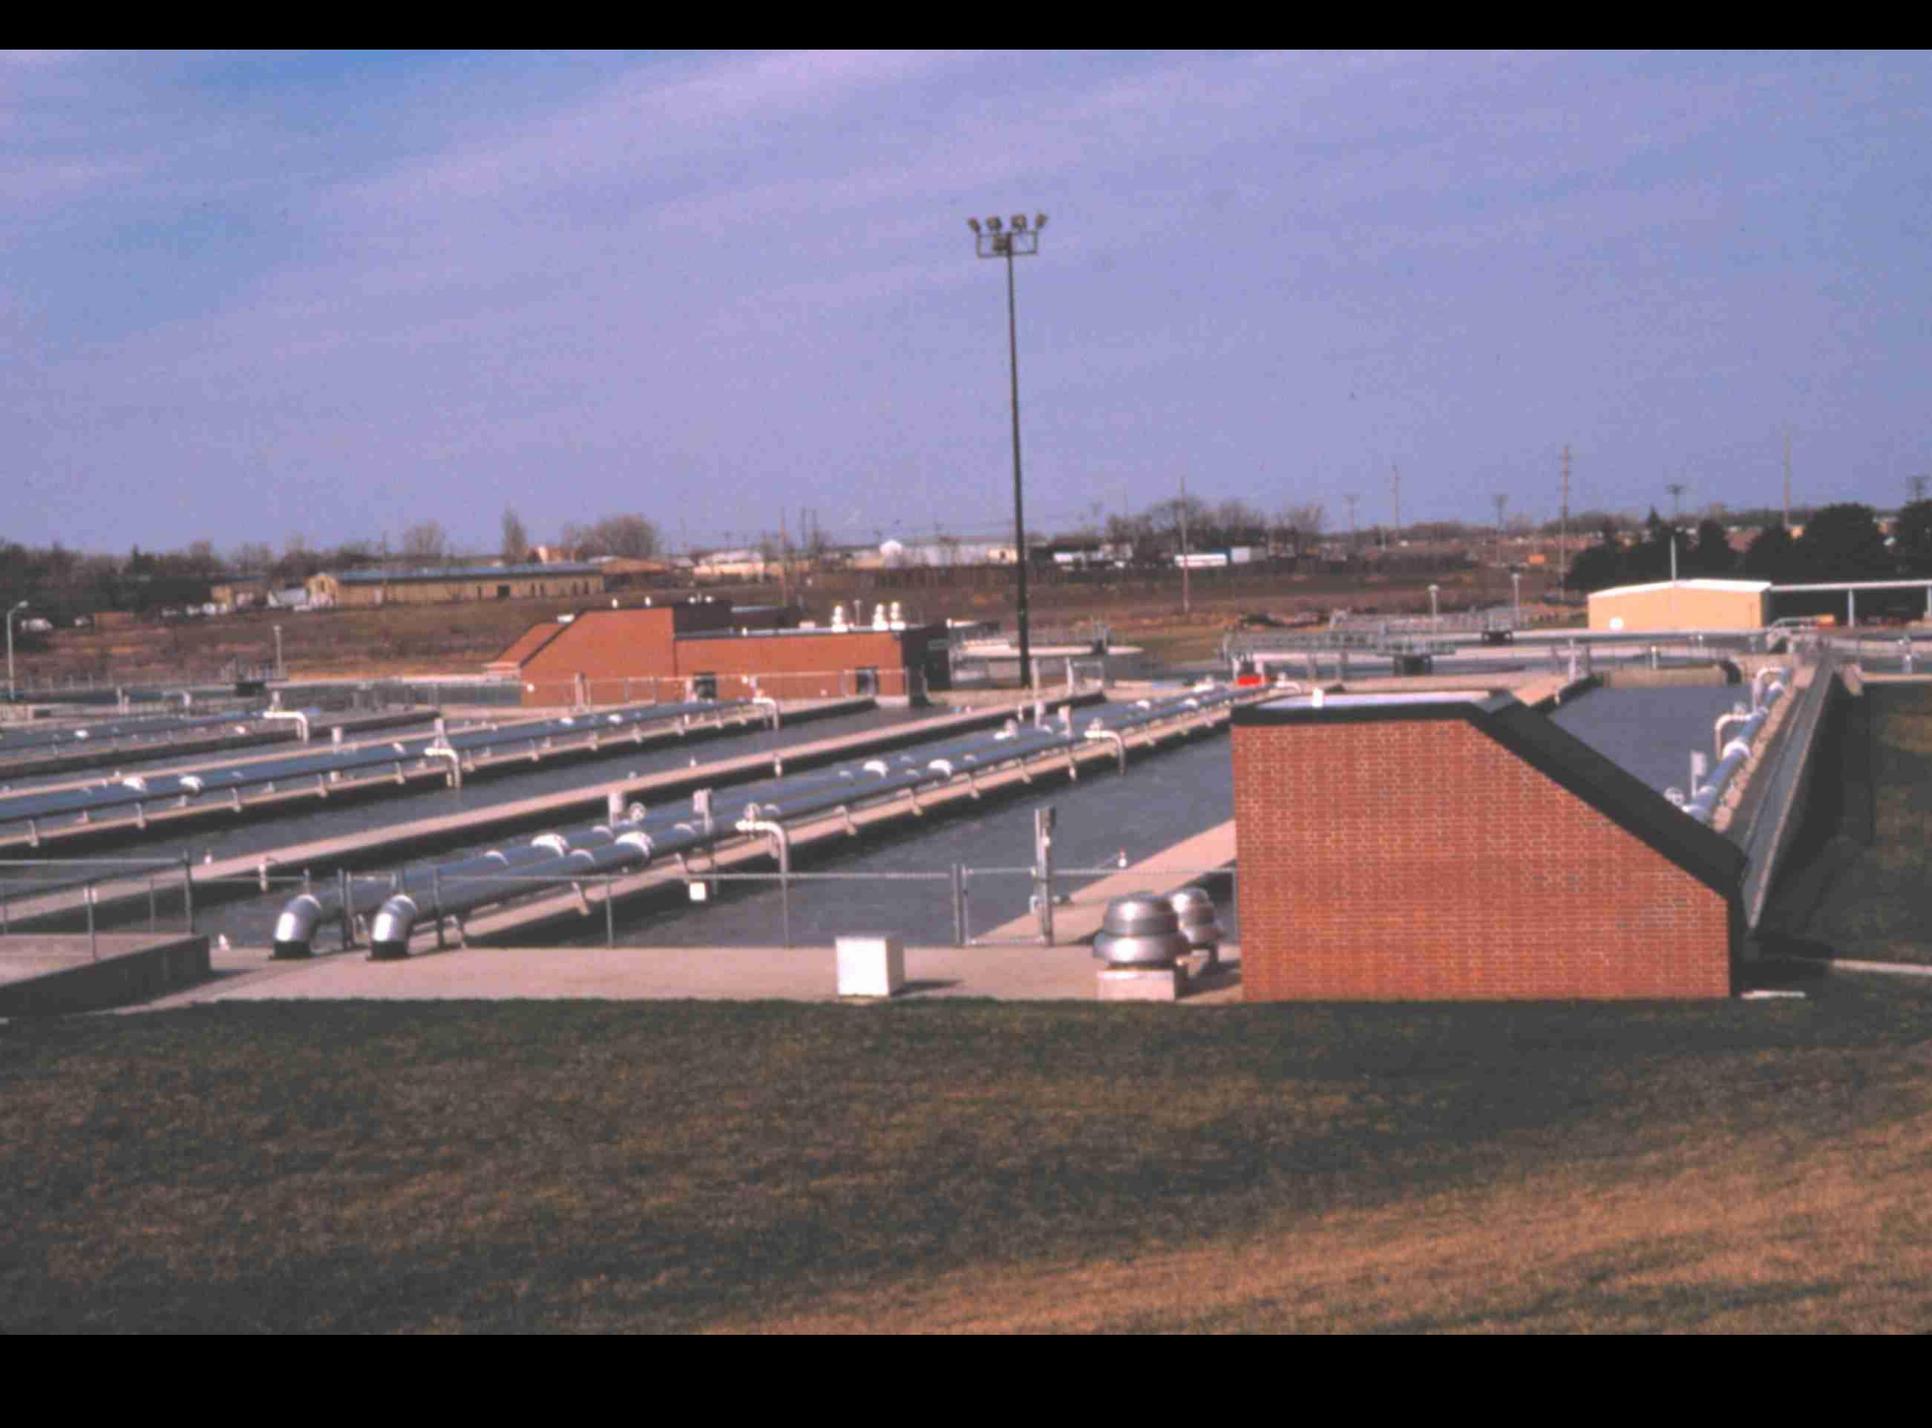
# Sources of Nutrients to Delavan Lake

**Point Sources Contribute ~76% of the Phosphorus Loading to the Lake**

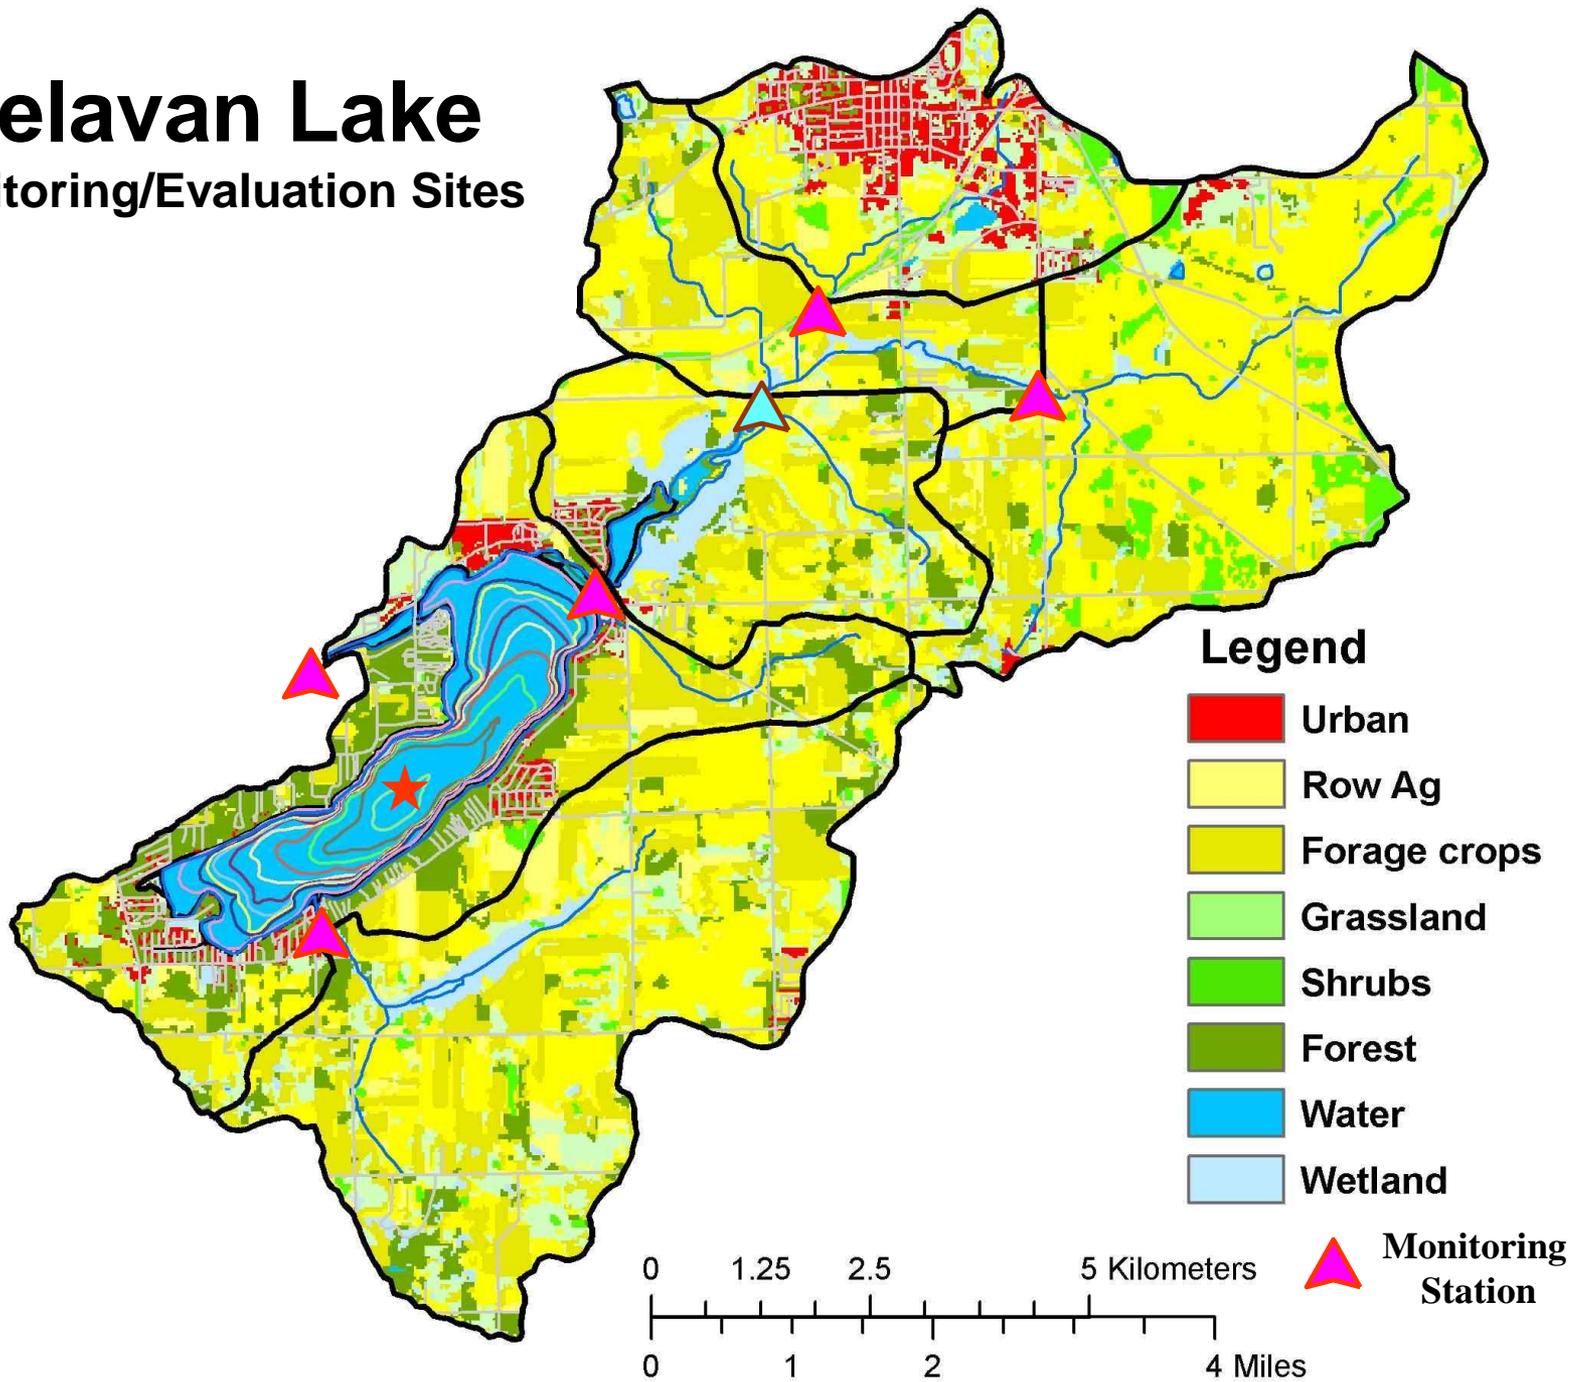
# Delavan Lake

## Monitoring/Evaluation Sites

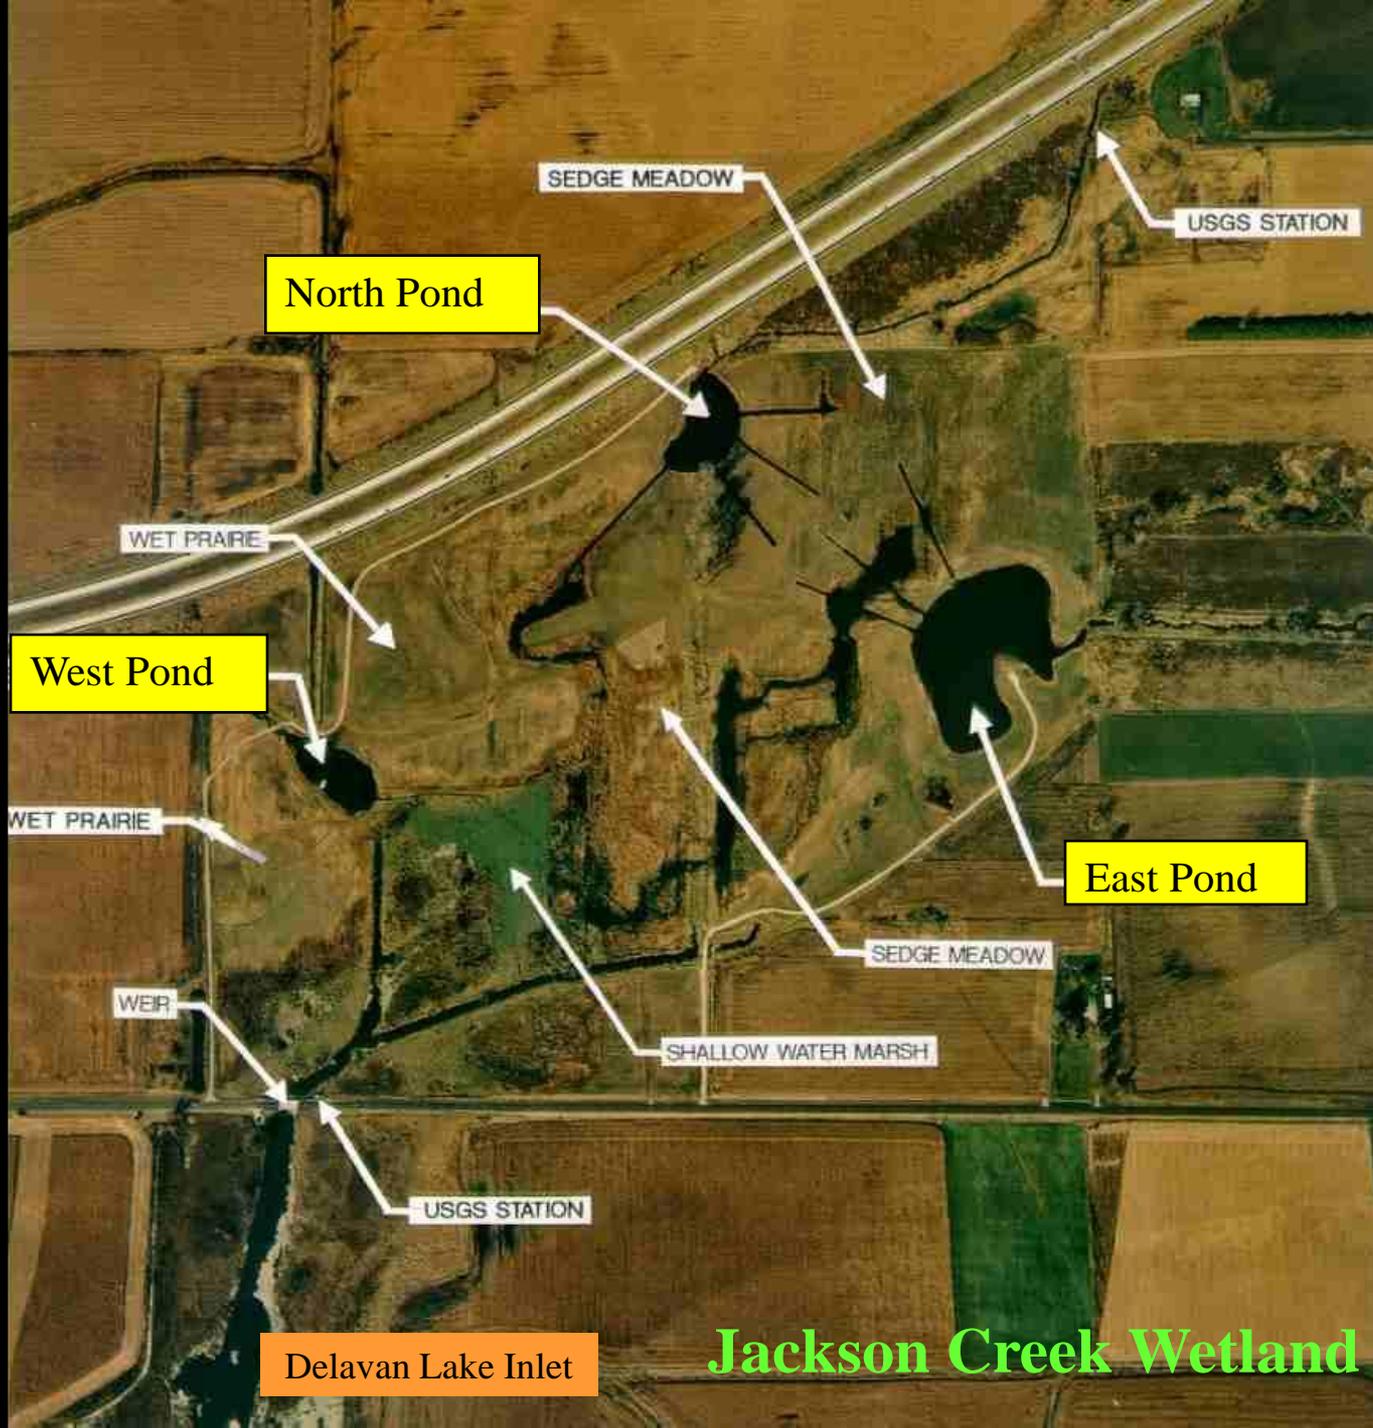
Jackson Creek Wetland

North Pond

West Pond

East Pond

WEIR

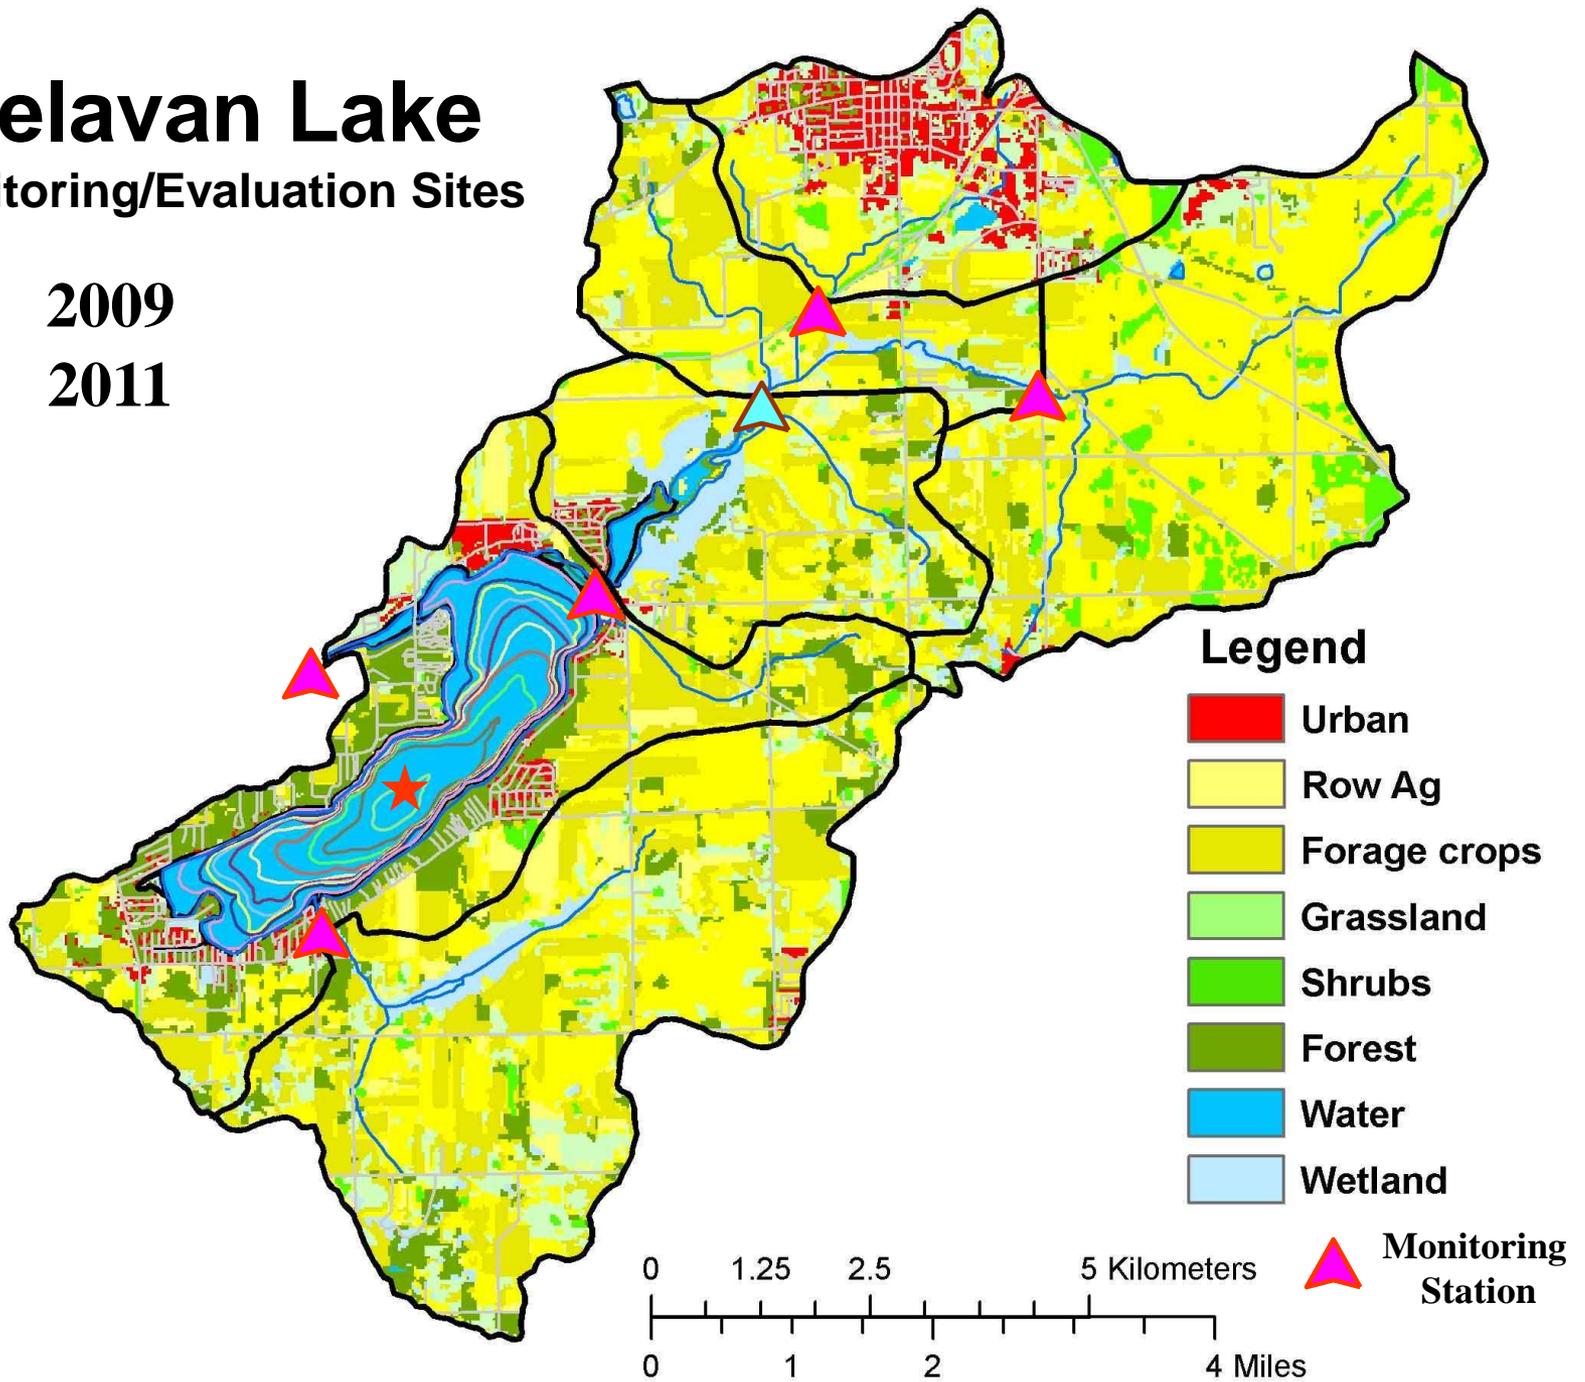
# Delavan Lake

## Monitoring/Evaluation Sites
